# BRADFORD ABBAS FINGERPOST REFURBISHMENT

## Background

## The Pilot Project

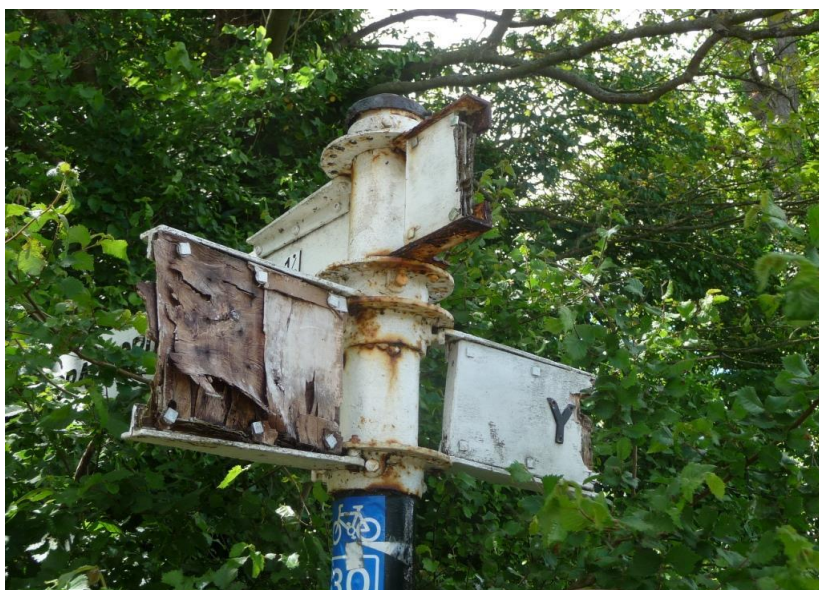
The fingerpost selected was the one at the Back Lane/Underdown/Old Compton Lane junction since it was very accessible. Unfortunately it was a very old design with lots of components and in very poor condition.

**Figure 1 The Post in Original State**

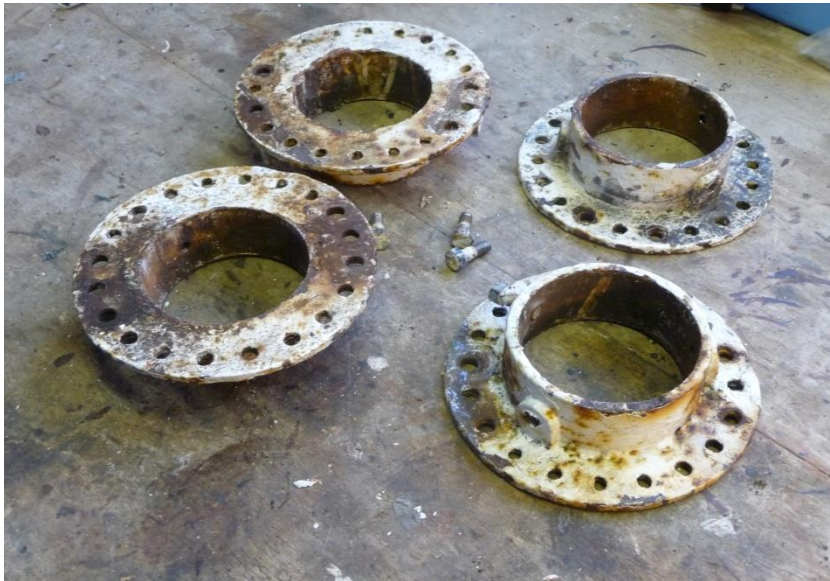
The original intention to just replace the arms was abandoned given the poor state of the metalwork and the post was dismantled, albeit with some difficulty as all bolts and fixings were badly corroded. Each finger is attached to top and bottom bracket arms with six bolts, nuts and washers. Each bracket arm is bolted to a heavy cast flange collar which has a series of radial holes allowing the bracket arms to be mounted pointing in the desired direction. So there are four collars in all, each of which is held to the post by three bolts. All sixteen arm fixing bolts were so corroded that they had

to be sawn and chiselled off. All twelve collar fixing bolts had to be treated with a blowtorch to loosen them sufficiently for removal and three finally had to be drilled out because the bolt heads were so badly corroded they snapped off.

**Figure 2 Removed Collars**

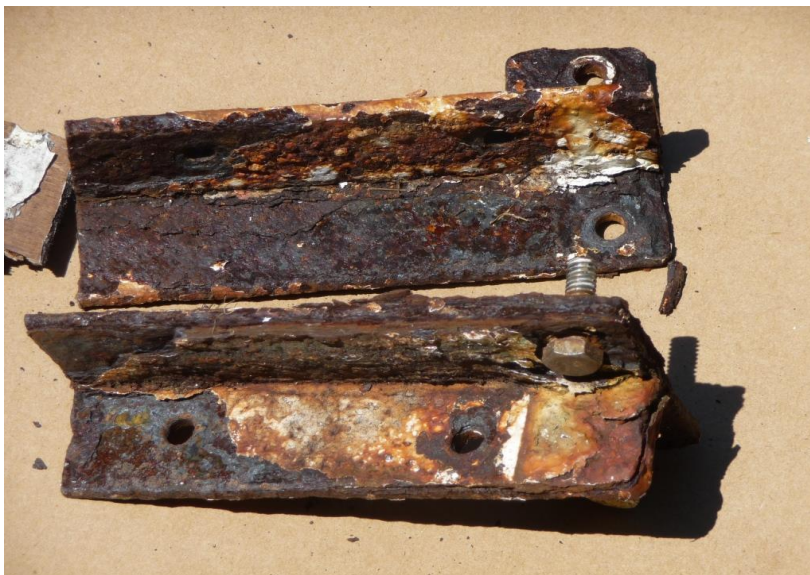
There were two non-standard bracket arms which were in such a bad state that I had to remake them. Material source was a 1920s bed frame. Never throw anything away!

**Figure 3 Non-Standard Arm Brackets**

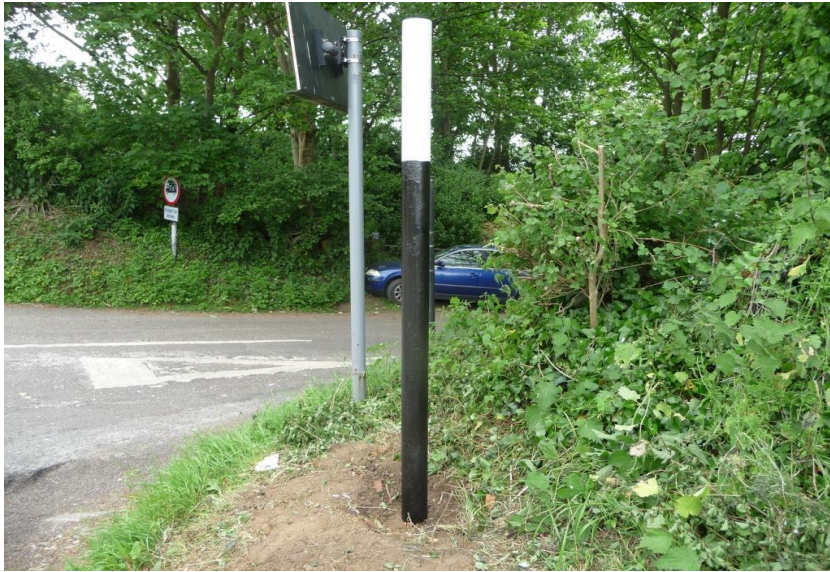
**Figure 4 Cleaned and Painted Post**

The post was cleaned with an aggressive power wire brush to remove all loose paint and corrosion and sanded smooth. It was then painted with three coats of Hammerite paint including a section below ground.

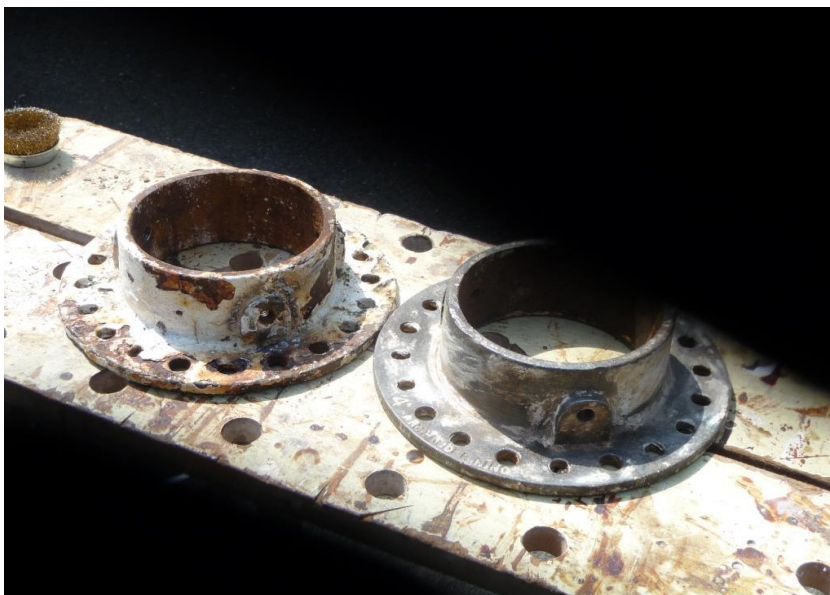
**Figure 5 Collar Before and After Cleaning**

The collars and bracket arms were thoroughly cleaned to remove rust and then repainted with four coats of Hammerite paint.

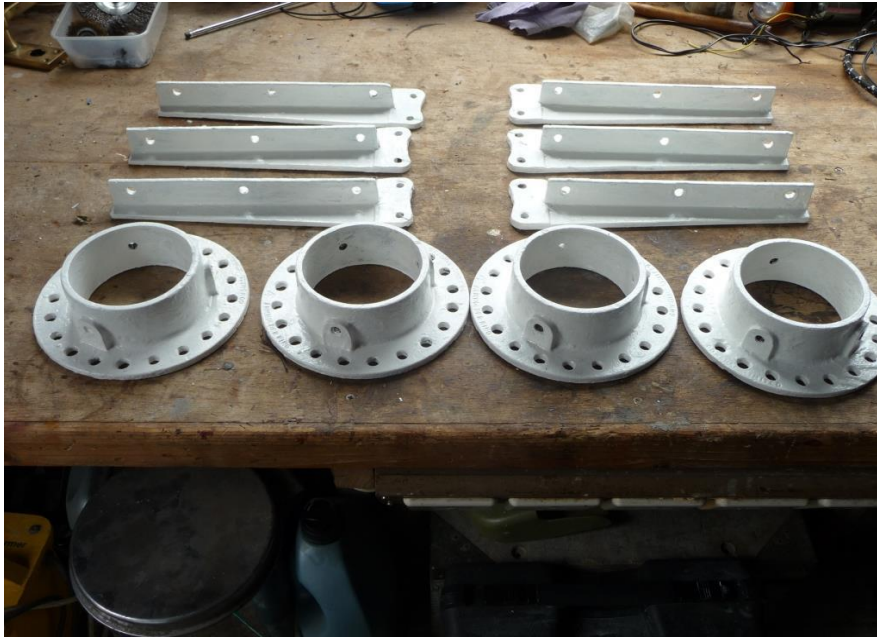
**Figure 6 Renovated Collars and Bracket Arms**

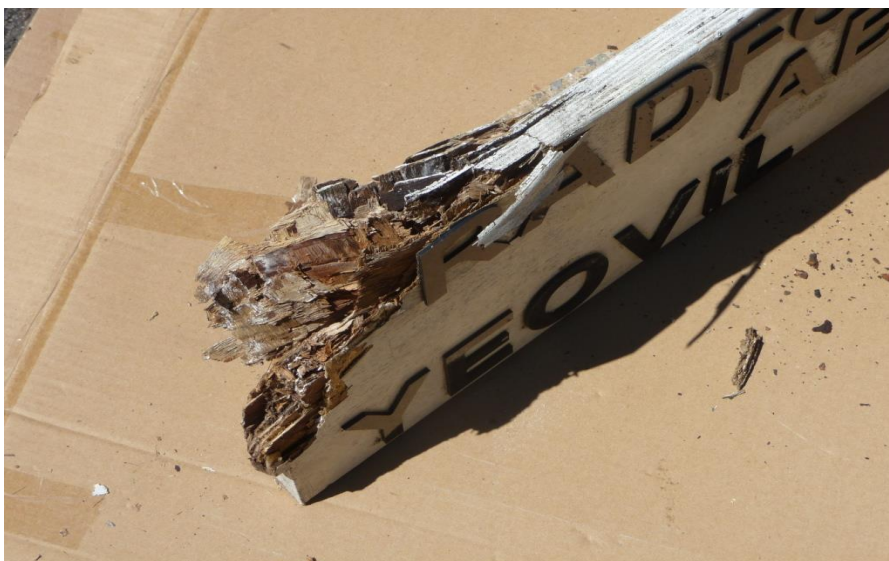
**Figure 7 What Happens to DCC Highways Plywood Arm Fingers**

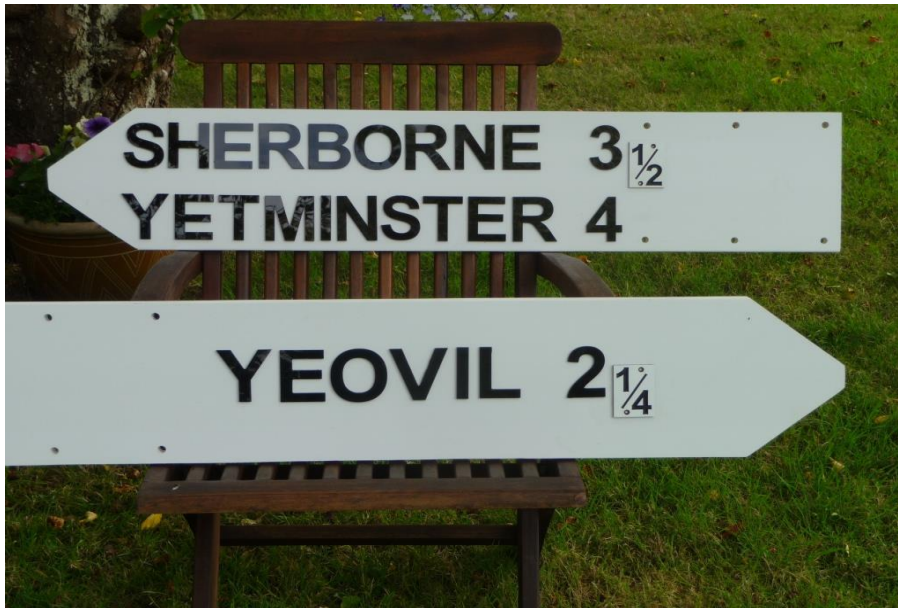
**Figure 8 New 18mm Thick uPVC Arm Fingers**

The four finger arms were then remade. It was possible to rescue some lettering from the one remaining finger (Bradford Abbas) but all remaining lettering had to be purchased. This entailed a bit of guesswork. Firstly what was written on the arms? A thorough search of the undergrowth and adjoining Haines property revealed no sign of them, but Google Street View (2011) gave the answer to this and also showed what a good state all the hedges and posts were in in 2011! Secondly, what was the letter form? A session on Microsoft Word suggested that it was Arial Bold so I risked it and from the firm I had previously found ordered 68 letters 64mm high by 3mm thick in Arial Bold, high gloss, black. Thankfully they were an exact match. The only alteration that I made was to change the Sherborne/Thornford finger arm to Sherborne/Yetminster as the post at the next junction has Yetminster on it but not Thornford. The next one down at Grants Hill/|Old Rectory junction has (had) both Thornford and Yetminster, so this seemed more logical and helpful.

The lettering was glued to the arms. Two types of glue were evaluated by sticking letters to a uPVC offcut and assessing how difficult it was to remove them 48 hours later. The winner was glue formulated for hard plastic which is specified down to -30C and can also be used on outside plastic building materials such as plastic guttering. So it should be OK with the summer and winter temperature differential between the white uPVC board and the black acrylic lettering.

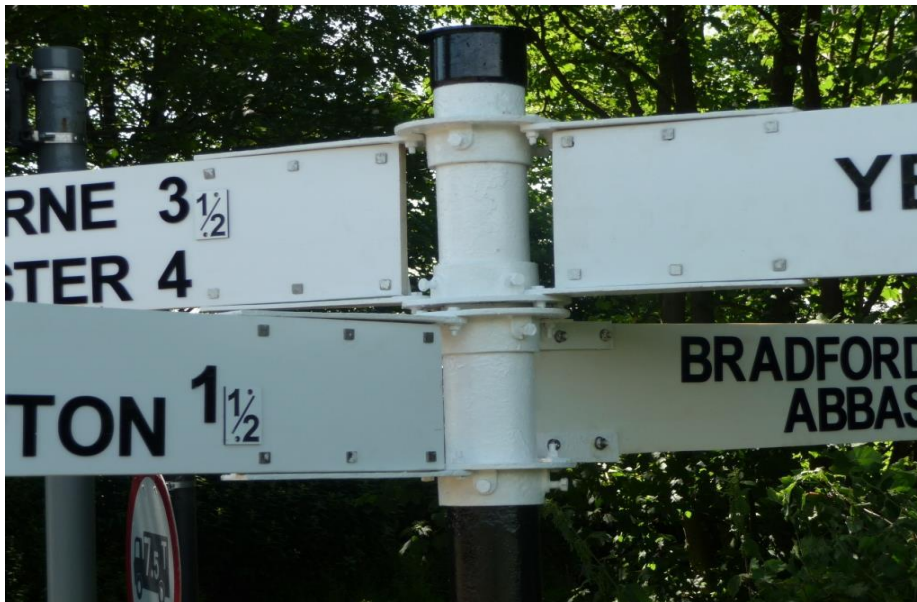
**Figure 9 Reassembled Components on Pole**

The finished metalwork and new arms were then rebuilt onto the refurbished pole.

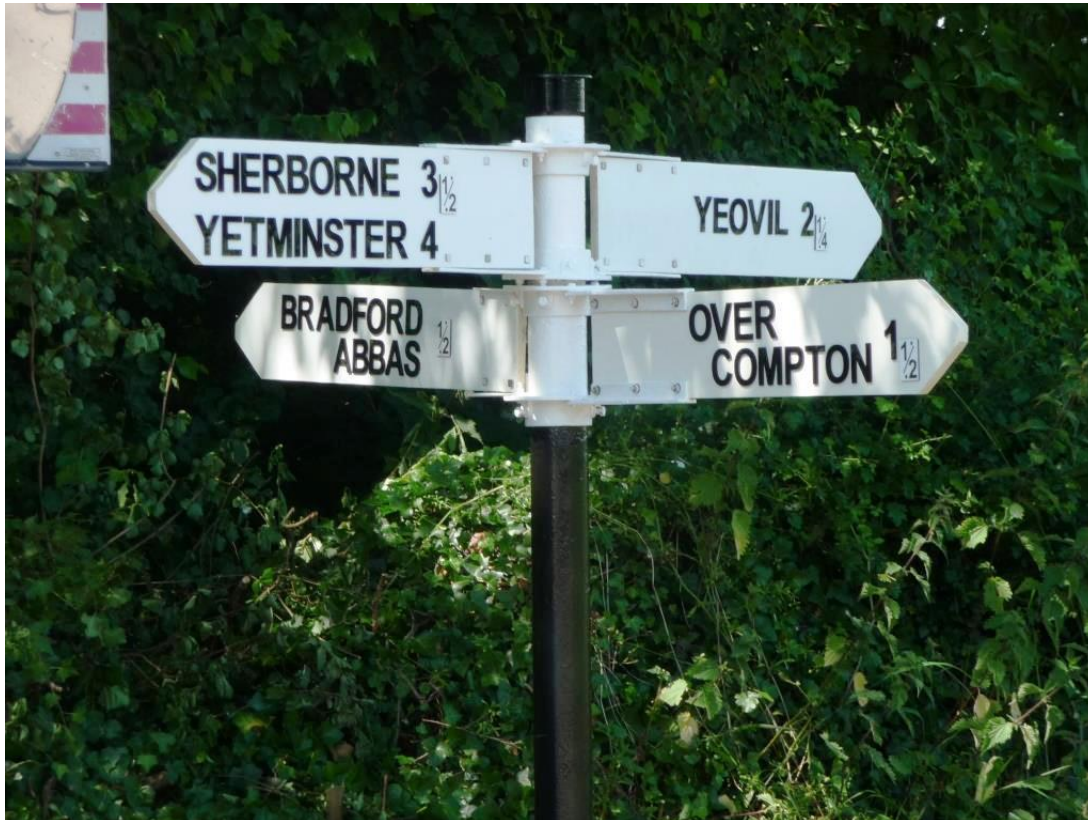
The old finial on top of the pole had fallen apart. It was as simple metal cap held on with three screws and not the shaped one on some other fingerposts in the village or the traditional Dorset

**Figure 10 Completed Job**

circular ones (often with the grid reference on them) that we have on two of our other posts. The DCC Sign shop had no finials so the only solution I could come up with was a 110mm 'stop end' used in plastic underground foul water drainage to block off unused branches. £3.99 in Wickes, or £12 in Jewsons or other builder/plumbing merchants - so we have the Wickes one painted with black gloss paint.
