Refurbishment of the Westbury/Bishops Lane Fingerpost

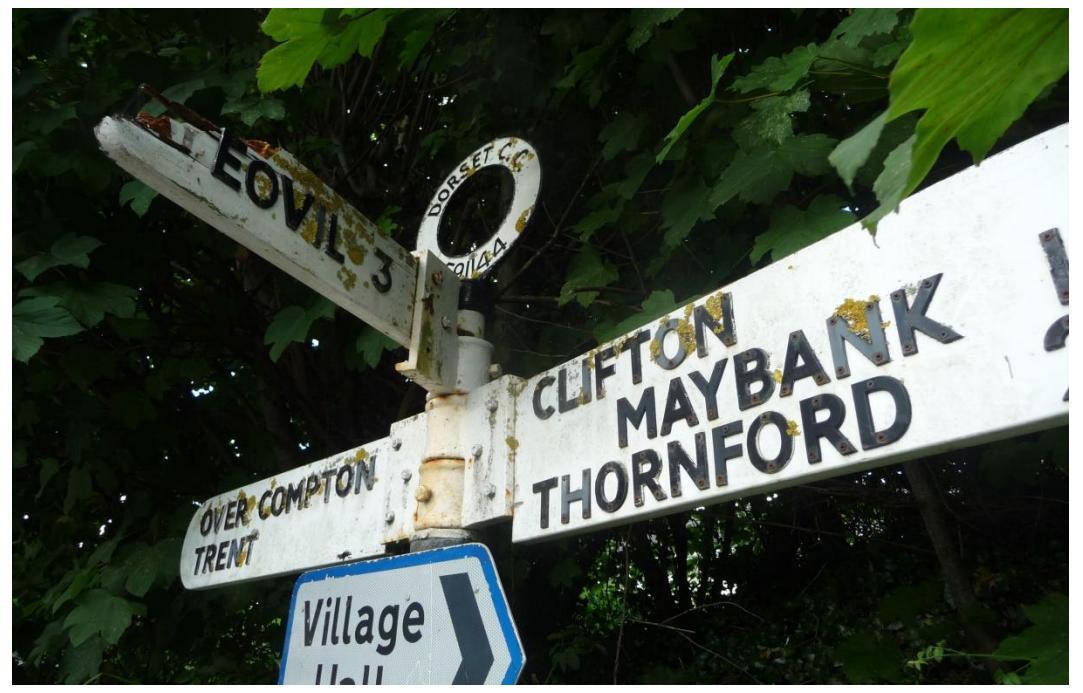
Post Before Refurbishment

Following a meeting at the post with Bob Skett, Peter Clark and Jim Clegg, who had all previously responded to the Parish Council request in the Pennant for volunteers, it was decided that the best approach was to dismantle it for complete cleaning and repainting.

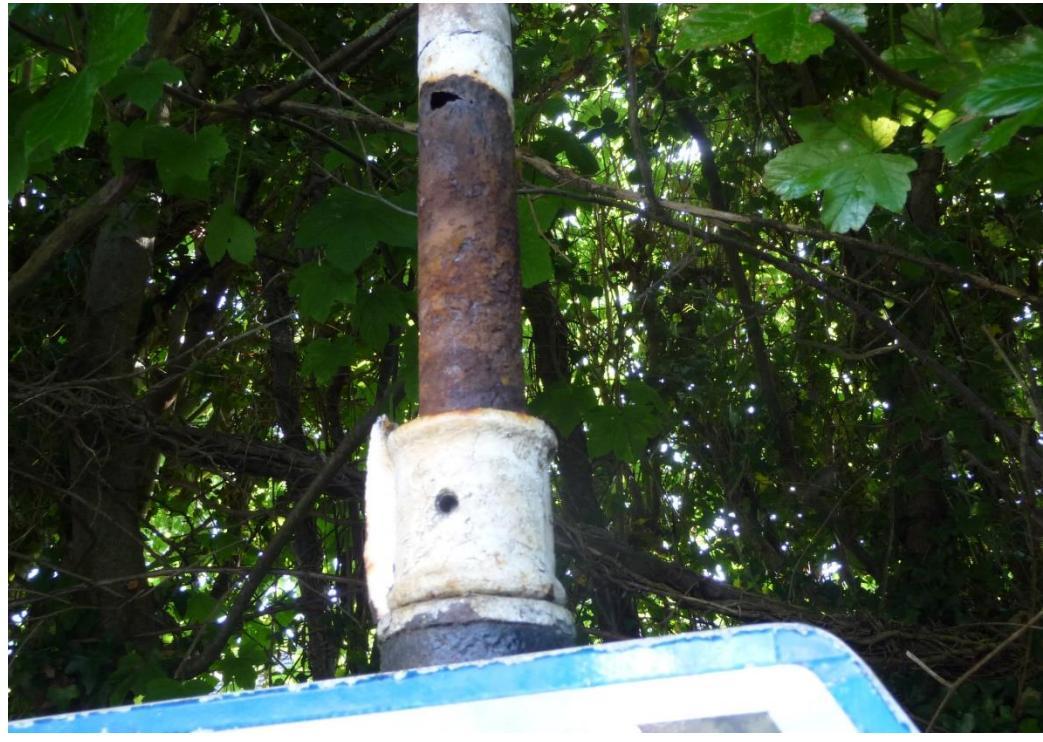
I had already removed the wooden fingers and Bob volunteered to remove the finial and finger brackets which he did with Jim's help. The lower bracket securing bolt sheared off during disassembly due to corrosion and the bracket itself was cracked to point that it broke off its collar during removal. The securing bolt was drilled out but the bracket collar was completely seized on the spindle due to corrosion.

Corroded Spindle With Broken Bracket Collar Still Attached

I later tried shifting it by applying heat from a blowlamp with the help of Graham White who came out from 'Highcroft' to see what I was up to, but to no avail. Graham and I then drilled the bolt through the collar and spindle and after much effort got it off. Graham's unsolicited help was very much appreciated and he spent all morning and a good part of the afternoon helping to remove the corroded parts, including supplying drill bits and the power for the drill.

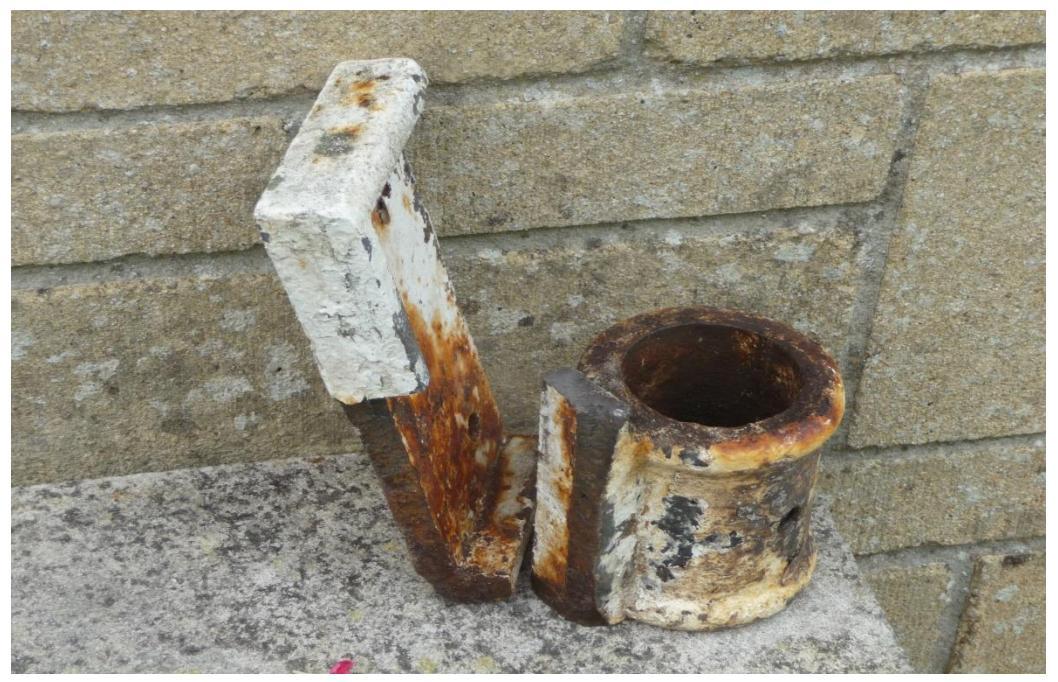
Broken Bracket and Collar

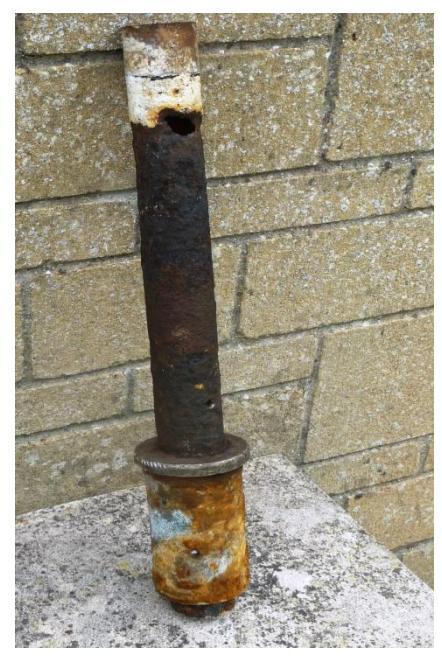
The spindle was very badly corroded and it was decided to take it off for

refurbishment/replacement. It was found to be mounted in an alloy sleeve of about 7 inches length that was secured internally to the post by three countersunk socket head bolts. A cobalt drill bit had to be purchased to drill these out using a hefty mains powered drill. The sleeve would still not shift and it took another week of lubrication and use of a lump hammer and cold chisel before I got it out.

Spindle and Flange

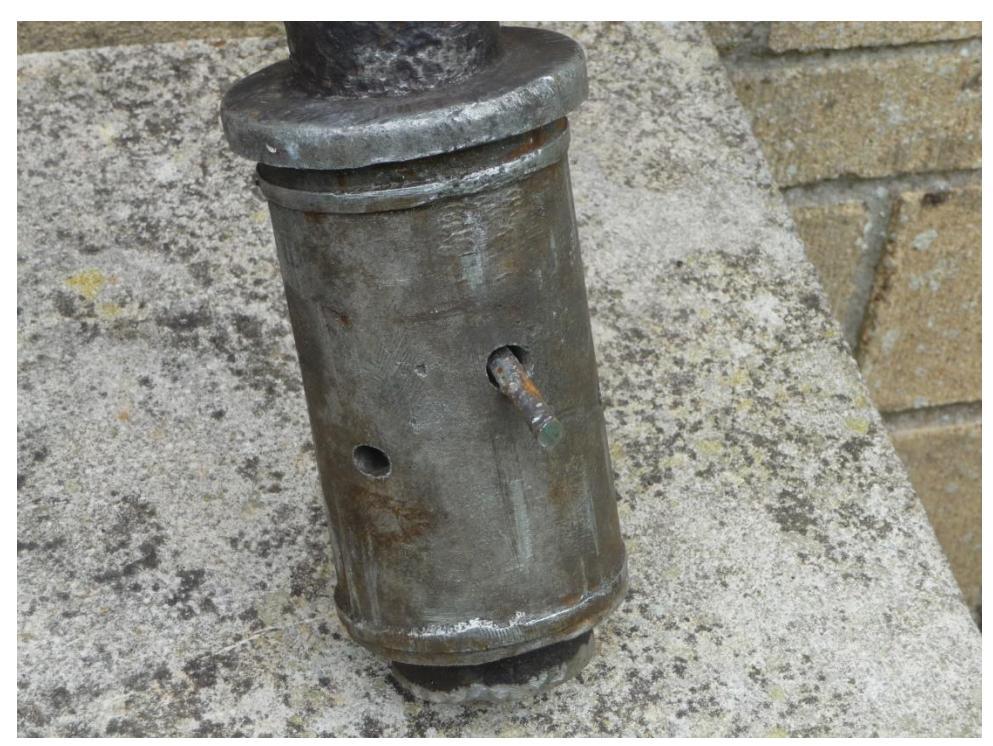
Over the coming days I found it impossible to get the spindle out of the sleeve. It was secured by a steel rod that appeared to run through the spindle and sleeve wall and then been flow welded over, although there was no sign of this on the outside of the sleeve. The rod was drilled out but it was still impossible to move the sleeve.

Cleaned Flange and Steel Securing Rod

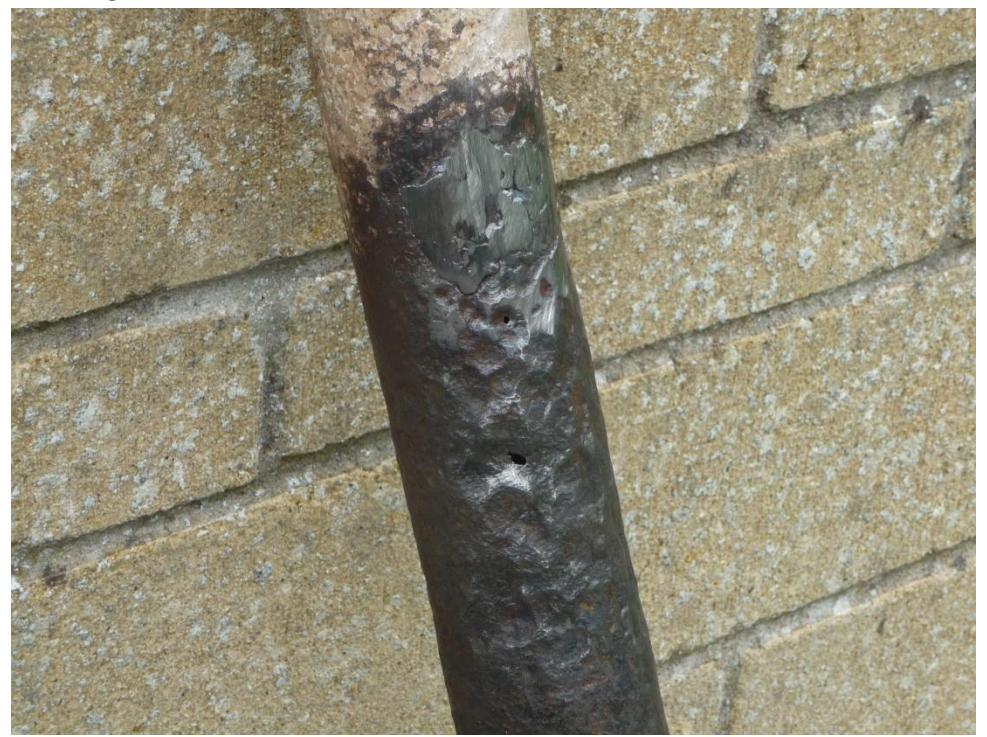
Spindle Weld Repair

An attempt to refurbish the spindle by welding over the large rusted hole near the top was partly successful but other pin holes were discovered over much of its length and the remaining sleeve wall

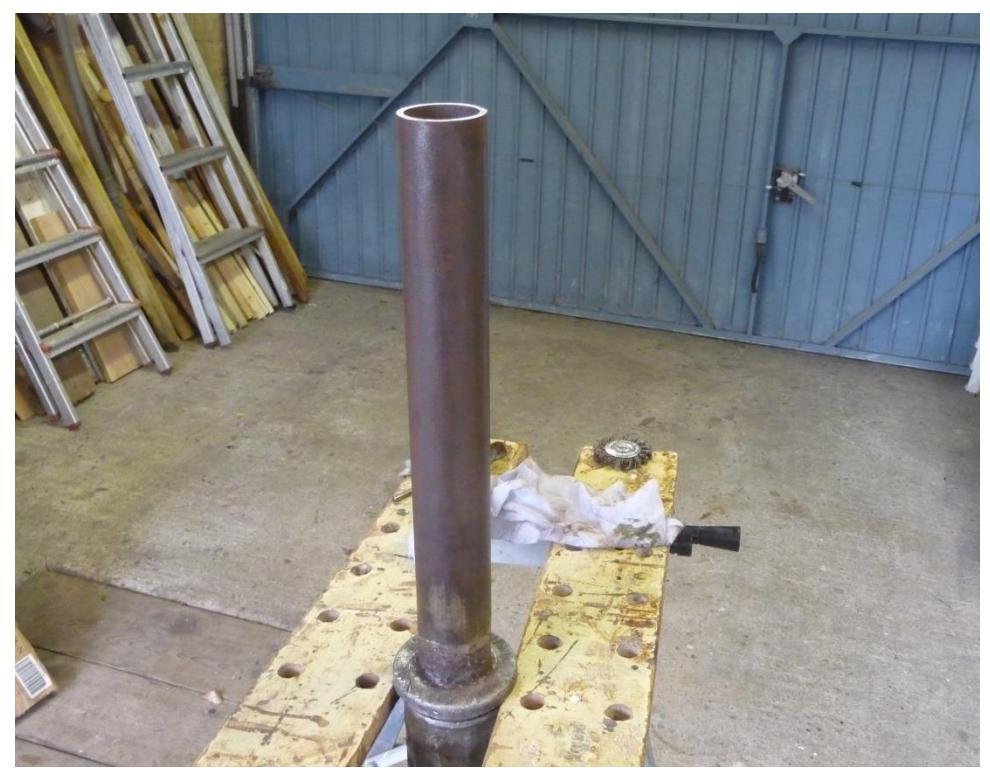
New Spindle Section Welded On

was thin in many places, so it was cut off just above the sleeve junction with the alloy flange and a new length of steel tube was welded onto it.

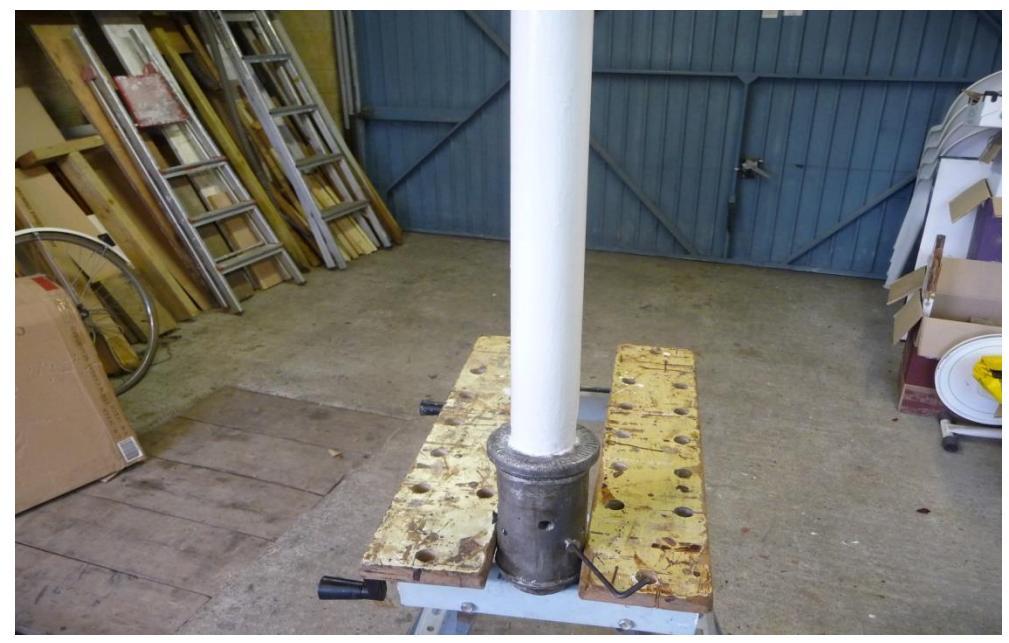
Repaired Spindle After Painting

The sleeve was then drilled and tapped to take three M8 countersunk socket head bolts to replace the ones drilled out. It was then painted with Hammerite white.

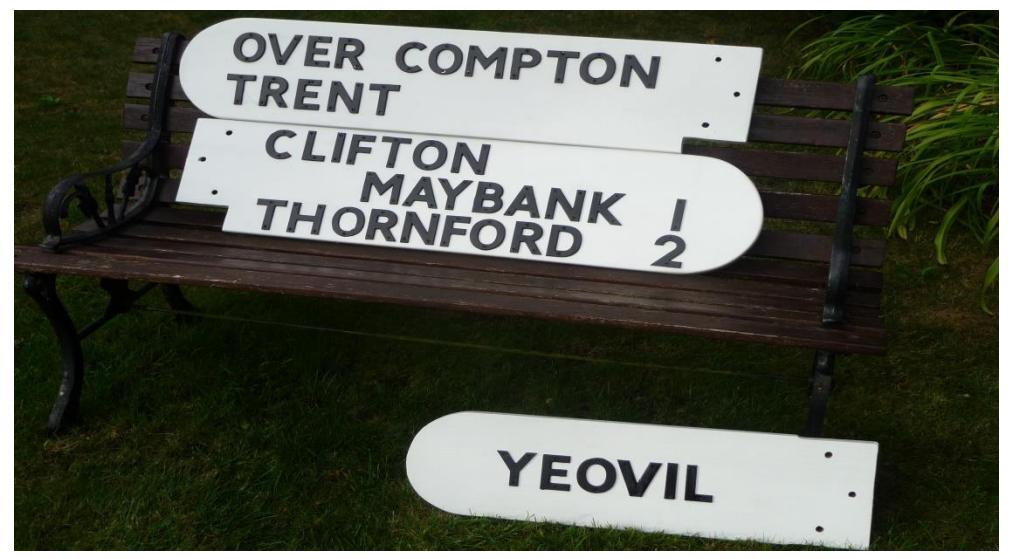
Refurbished Fingers and New YEOVIL Finger

The YEOVIL finger had previously been replaced at some point with softwood one and was completely rotten. I managed to restore the other two fingers and made a new one in oak bought from Yandles at Martock for the YEOVIL direction. They are painted with multiple coats of Sadolin microporous matt paint of the type coincidently recommended by AONB.

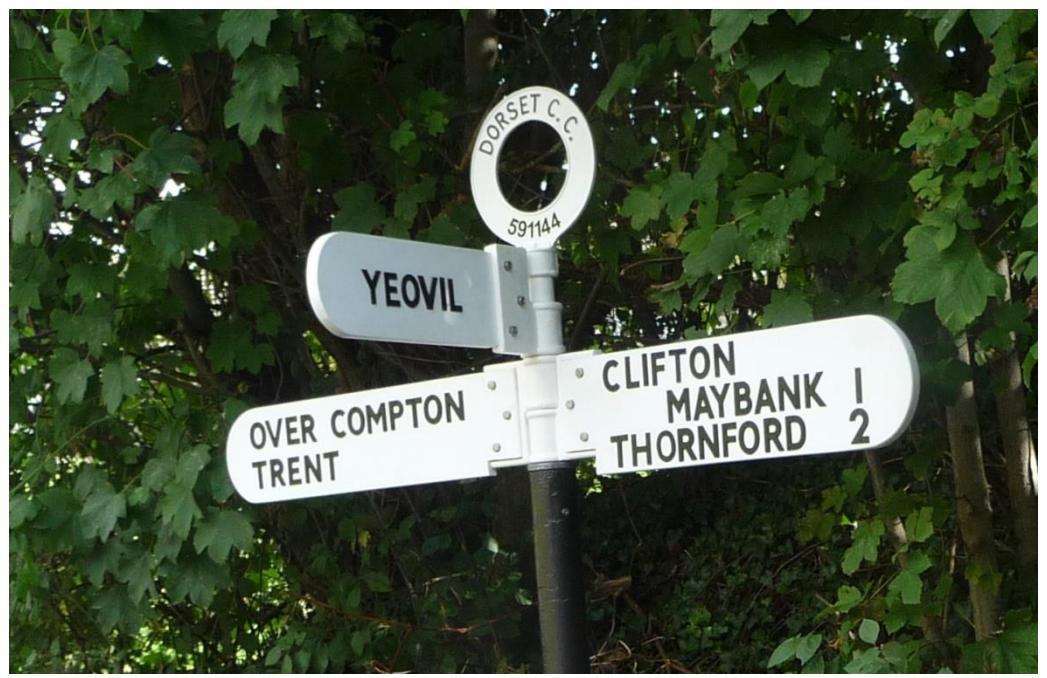
Refurbished Post

The post was repainted in black Hammerite . Bob and I put the post back together on Thursday 29th September. The fingers have new stainless steel bolts, washers and nuts and the bolts securing the bracket collars have been replaced. Plenty of grease has been used in the reassembly for future protection. The Village Hall sign was remounted on the post.
